NRL/FR/5520--03-10,048

Dragon Warrior Communications Relay Testing Using the K-MAX Helicopter

April 14, 2003

DRAGON WARRIOR COMMUNICATION RELAY TESTING USING THE K-MAX HELICOPTER

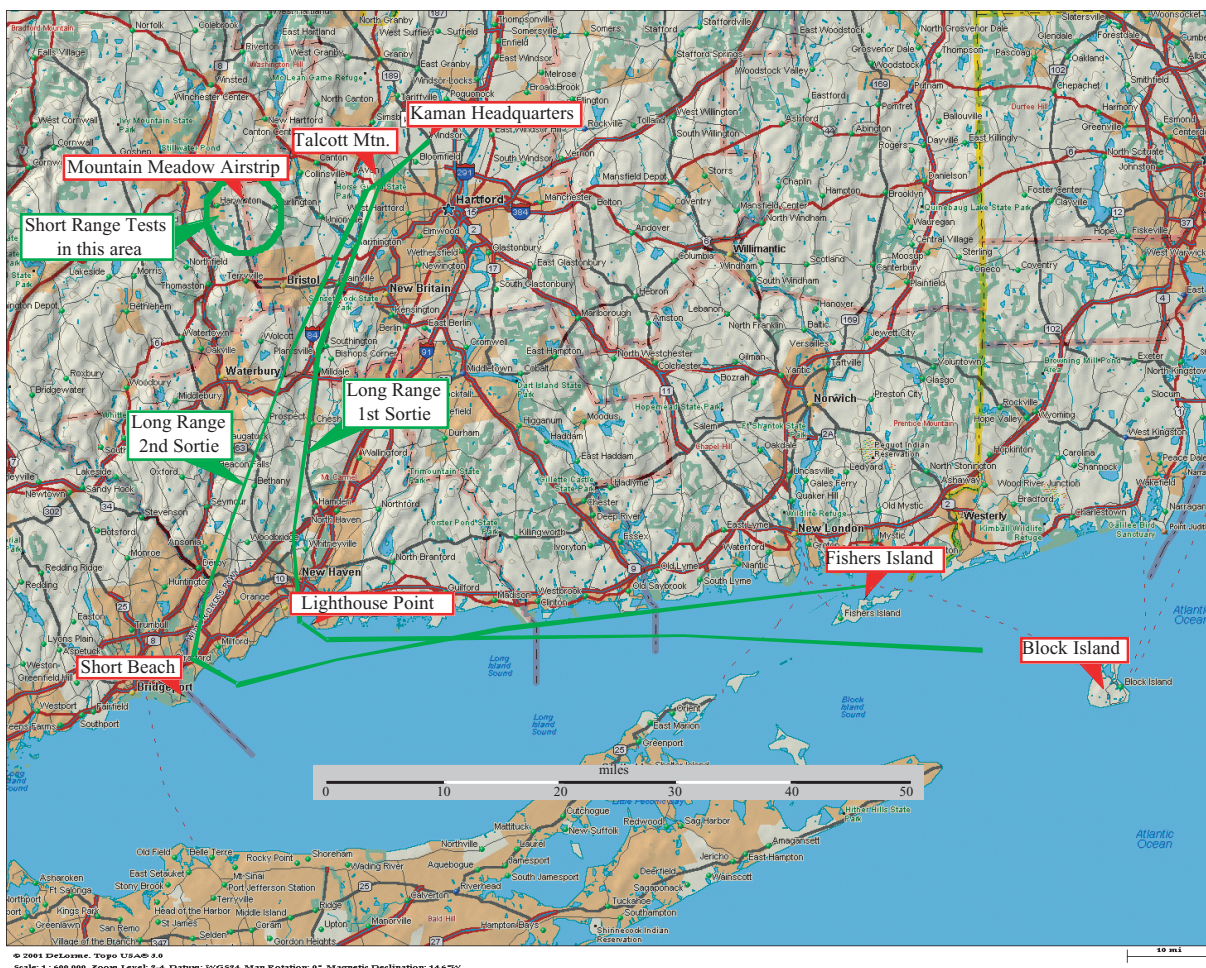
Fig. 1 — Test area for the Comm Relay tests supported both short-range and long-range tests that included overland and overwater flight paths

The test sites include Kaman Aerospace facilities in Bloomfield, CT; Mountain Meadow Airstrip in Burlington, CT; Talcott Mountain in Avon, CT; Lighthouse Point in New Haven, CT; Short Beach in Bridgeport, CT; Fishers Island, CT; and Block Island, RI. Figure 1 shows the test area and the locations of the various sites.

Ground-to-ground tests were performed near Kaman Headquarters in Bloomfield, CT; the low-altitude short-range tests were performed in the vicinity of Mountain Meadow Airstrip in Burlington, CT, and the long-range tests were performed in two sorties over central Connecticut and Long Island Sound. Sortie 1 covered the area from Bloomfield, CT, to Lighthouse Point, CT, to Block Island, RI. Sortie 2 was from Bloomfield, CT, to Short Beach, CT, to Fishers Island, CT. No ground station had clear line-of-sight to any other ground station. Table 1 lists distances from various test. Aircraft flight pattern and altitudes were based on FAA flight restrictions and weather conditions. Overwater altitude was typically 4500 to 5500 ft. Overland altitude varied from 1500 to 4500 ft.

For the first sortie, the flight path (shown in Fig. 1) began at Kaman headquarters, went past Talcott Mountain, past Lighthouse Point, to Block Island, and returned by retracing the same path. Talcott Mountain provided a good “high ground” vantage point for maintaining long LOS over much of the terrain. Lighthouse Point provided a good vantage point over water to the south. However, as we discovered during this test, the view to the east (which is the direction the flight path followed) was obscured by a nearby tree line. Figure 13 shows the connectivity between the K-MAX aircraft and the ground station at Talcott Mountain as a yellow line, and connectivity between the K-MAX and the ground station at Lighthouse Point is shown in purple. Areas where the yellow and purple lines are adjacent to each other is where the airborne node functions as a relay between the two ground stations.

For the second sortie, the flight path (see Fig. 1) began at Kaman headquarters, went past Talcott Mountain, to the vicinity of Short Beach, to Fishers Island, and returned by retracing the same path. Figure 14 shows the connectivity between the K-MAX aircraft and the ground stations for Sortie 2.

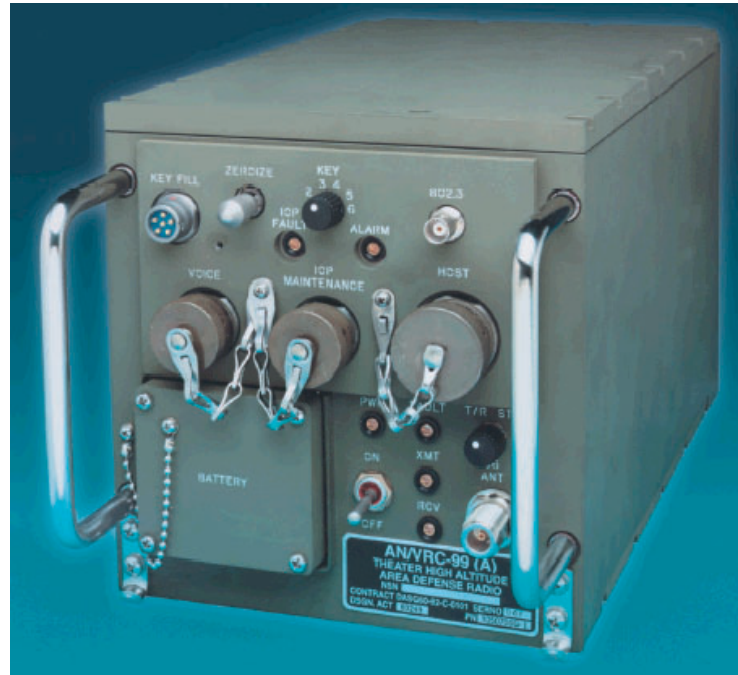
The AN/VRC-99A (Fig. 3) is a direct-sequence spread-spectrum network radio that can support data burst rates of 625 Kbps to 10 Mbps in networks of up to 16 radios. It provides a 10Base2 Ethernet interface for a local area network (LAN) and Type 1 encryption of user data. It provides 10 W of output power in the 1308 to 1484 MHz frequency range.

Fig. 3 — The AN/VRC 99A is the network radio for Comm Relay

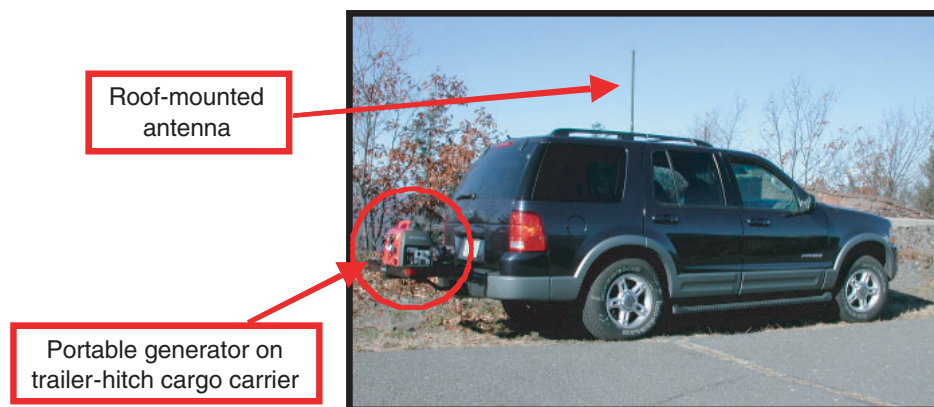
Fig. 7 — The ground station had a roof-mounted antenna and a portable generator mounted on a trailer-hitch cargo carrier to provide power

The ground station included the network radio and Comm Relay controller, but it also required additional equipment because the 28 VDC required by the VRC-99A was not available on the ground vehicles. A portable generator provided 120 VAC for all of the ground station equipment. An Accopian 28VDC power supply powered the VRC-99A, and standard AC power adapters were used for the laptops. Any additional auxiliary systems could be connected to the ground station's LAN via a NetGear EN104 Ethernet hub. The radio antenna was connected directly to the VRC-99A and mounted on the ground vehicle roof via a magnetic mount and cable ties attached to the roof rack. Figure 6 is a system diagram for the ground units, and Fig. 7 shows one of the ground stations with the roof-mounted antenna and the generator mounted on a trailer-hitch cargo carrier.

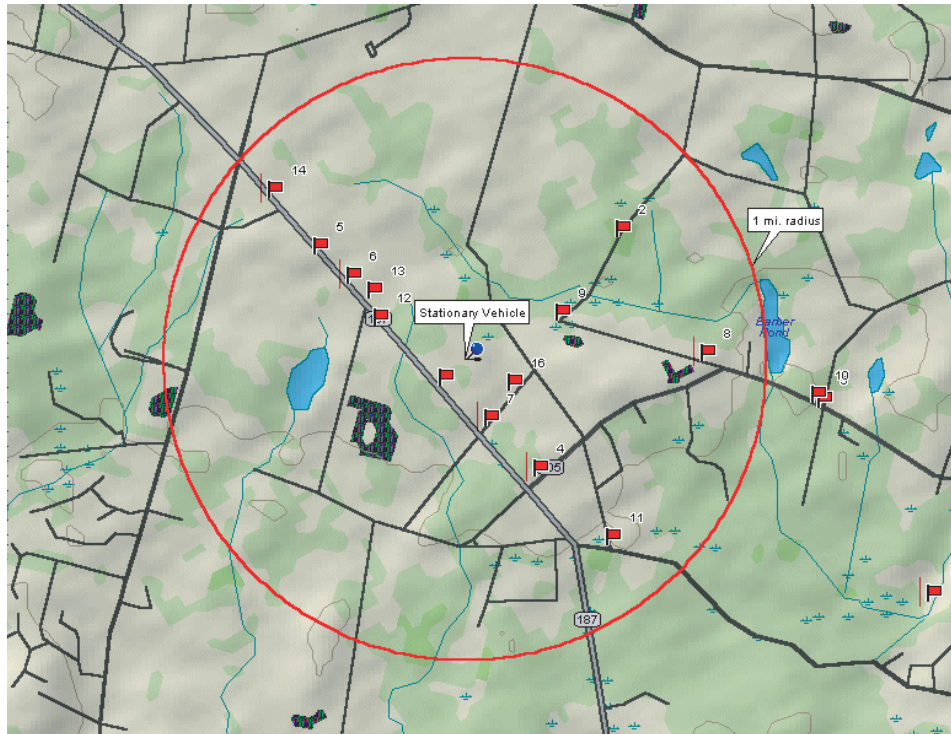
The test setup comprised one stationary vehicle with a second mobile vehicle following radial patterns emanating outward from the fixed node's position. Figure 11 shows the area of the tests, with the stationary vehicle positioned in the center, and flags positioned at locations where the signal was lost (when the mobile vehicle was moving away from the stationary vehicle), or where the signal was recovered (when moving toward the stationary vehicle). A circle with a 1-mi radius from the stationary node is drawn for reference.

Fig. 11 — The ground-to-ground tests were performed around a central stationary vehicle within a 1-mi radius (shown as a red circle)

The results of this test showed that the maximum achievable range was consistently less than 1-mi. Even though the radios were transmitting at 10 W, the foliage, terrain, and nearby buildings significantly blocked the VRC-99A's 1.4 GHz radio signals. Under these conditions, it is apparent that an airborne relay is necessary to provide connectivity between these radios, even at close range.

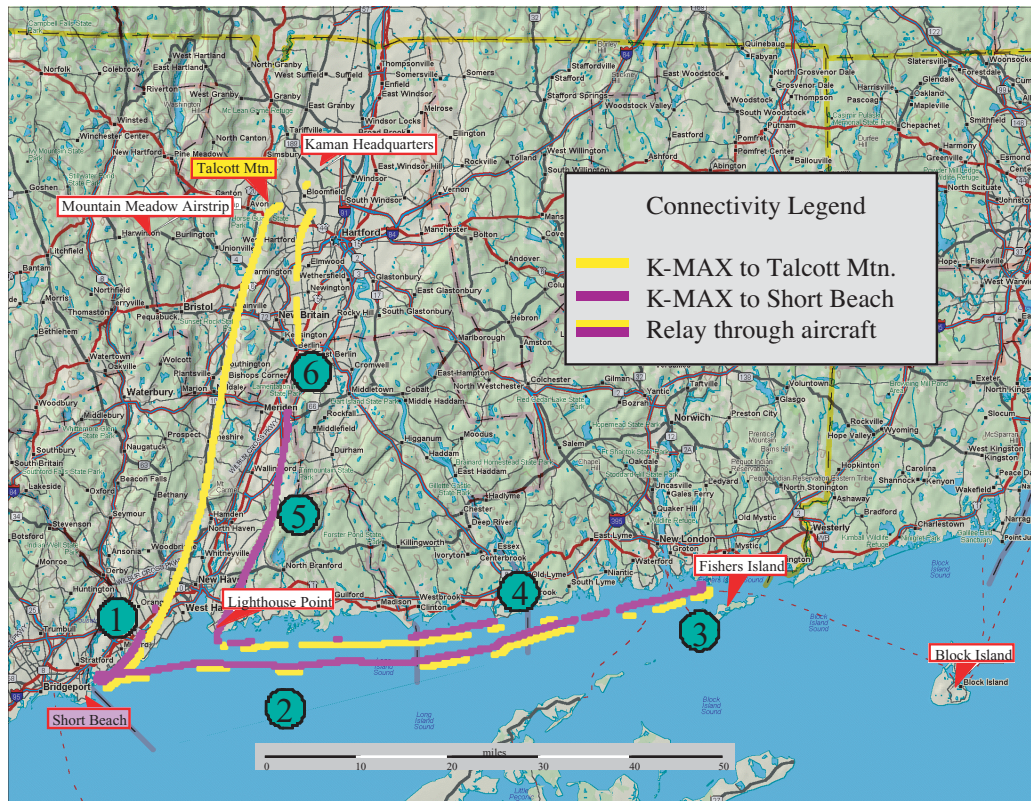
The second sortie provided some results that were consistent with the results of the first sortie, and some results that were improvements in performance. As with the first sortie, good connectivity was quickly established and maintained with the Talcott Mountain ground station. For this sortie, however, the K-MAX maintained high enough altitude to serve as a good relay to the Short Beach location (at (1)). When the aircraft started traveling eastward, connectivity was intermittent to Talcott Mountain but consistently was reliable to Short Beach (at (2)). Signal blockage by the mountains between Long Island Sound and Talcott Mountain were the major cause of drop-outs to that ground station. The Short Beach ground station had good connectivity, with only occasional breaks until the aircraft began its return path near Fishers Island (at (3)). Note that as the K-MAX began its return trip, it was communicating with both Talcott Mountain (at a

Fig. 14 — Connectivity between the K-MAX and the two ground stations during Sortie 2 shows the masking effects of the terrain and the aircraft fuselage

distance of 55 mi) and Short Beach (at a distance of 60 mi) and functioning as a relay between the two. This shows that with good LOS, the Comm Relay will be able to meet the target range requirements.

As soon as the K-MAX began its return trip, it again assumed a nose-down attitude to compensate for head winds. This again caused the antenna on the tail of the aircraft to be masked by the fuselage from both ground stations. The long range to the aircraft weakened the signal, which also contributed to the drop-out. On the return trip, the K-MAX altitude was increased to 5500 ft, which contributed to the signal being recovered (at (4)) by both ground stations, although antenna masking was still evident from the Short Beach location.

As the K-MAX turned northward, the antenna was no longer masked from the Short Beach location and connectivity was restored, but the Talcott Mountain location was now masked. This condition continued until the terrain blocked the LOS from Short Beach, causing loss of connectivity (at (6)). Shortly afterward, the K-MAX was close enough to Talcott Mountain to overcome the masking, and connectivity was maintained for most of the remainder of the test.
